**SUMMARY OF LIMITED PHASE I
ENVIRONMENTAL SITE ASSESSMENT
935-ACRE MONTECITO RANCH, RAMONA
SAN DIEGO COUNTY, CALIFORNIA 92065**

W.O. E2661-SC APRIL 21, 1999

Subject: Summary of Limited Phase I Environmental Site Assessment, 935-Acre
Montecito Ranch, Ramona, San Diego County, California 92065

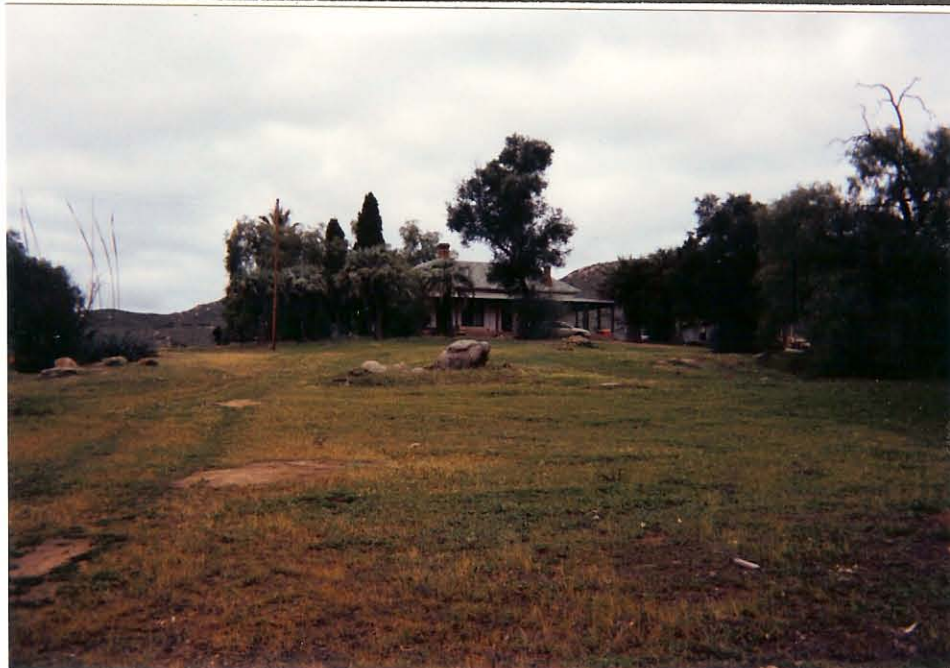
1. Main residence on Montecito Ranch. View is to northwest from dirt driveway.

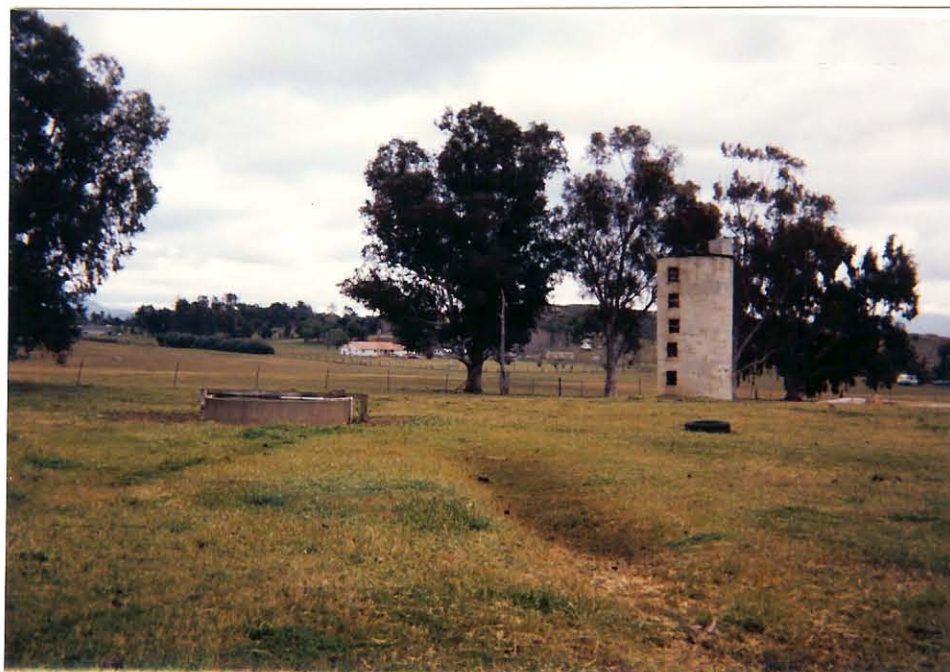
2. Grain silo and watering hole across driveway from main residence. View to the east, includes pasture land along the southern property boundary.

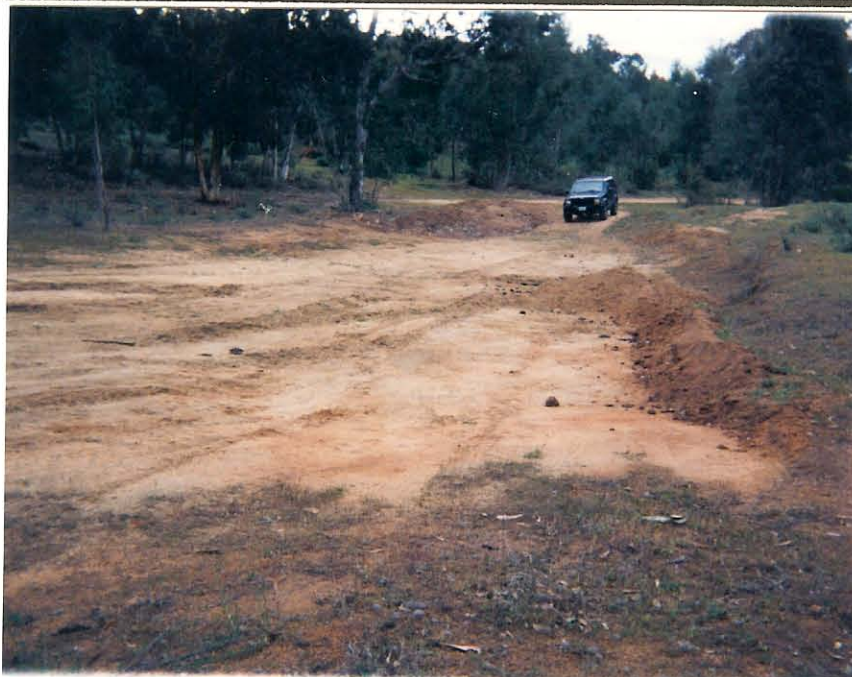
3. Excavation area in south central portion of ranch property. Area, located within rectangular tree cluster, was the previous location of the ranch dump. View is to southeast.

- All pertinent reports of the removal of the stockpiled trash should be provided to this office for review. Dependant upon the information provided, verification sampling may be considered to evaluate the existence of detectable chemical residues (if any).
- Considering that the majority of groundwater wells were abandoned by the previous owner at least 10 years ago, GSI recommends that all abandonment records/files be provided to verify that proper State of California abandonment procedures were followed (California Well Standards Bulletin 74-90). If proper records are not available, consideration may be given to contacting the California Department of Water Resources for their files. Although unlikely, wells onsite without proper abandonment records may need additional evaluation and possibility re-abandonment.

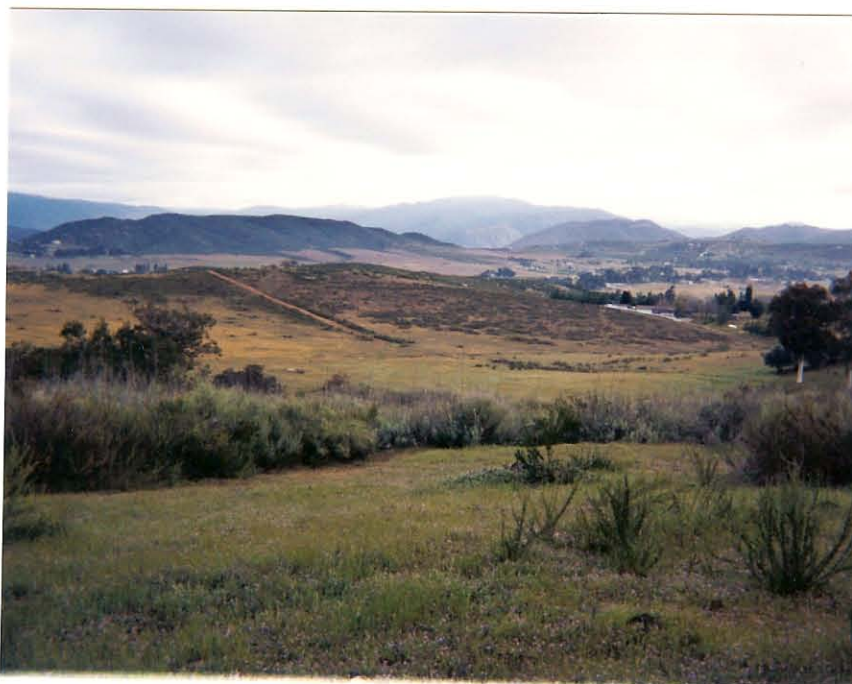
4. Northeast view of northeastern ranch property from near intersection of Ash Street and Alice Street. White house in background is offsite.

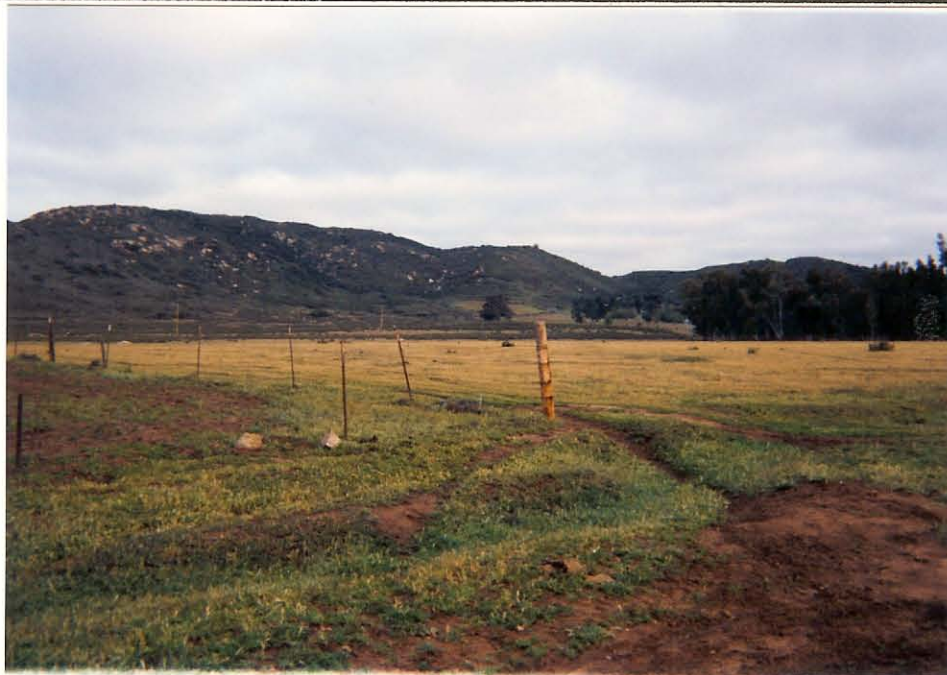
5. Northwest view of southwestern portion of ranch from northerly end of driveway to main residence. Majority of hillside in background is offsite.

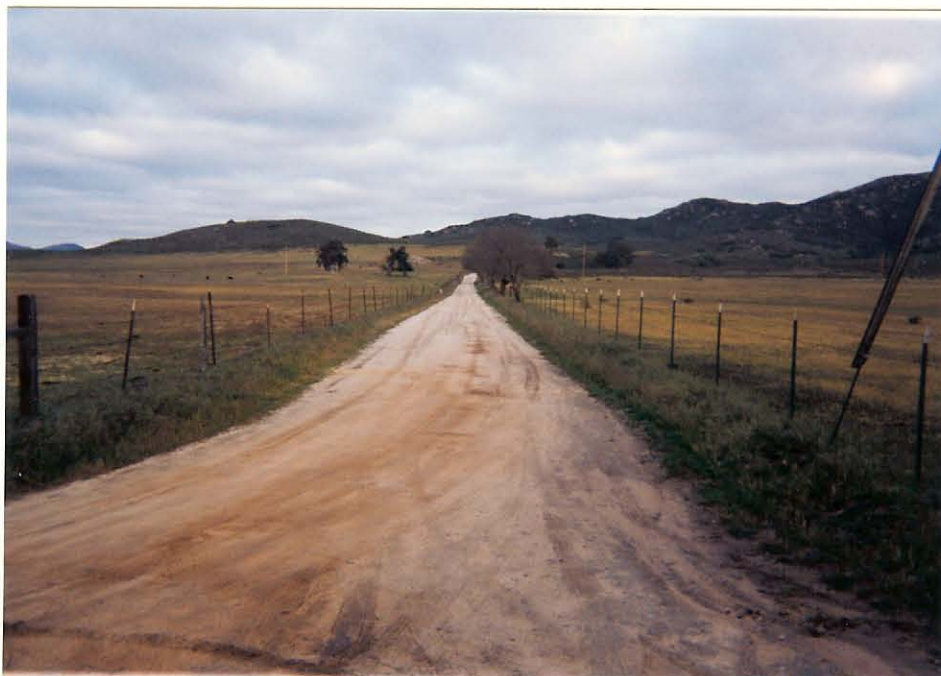
6. West view along Montecito Way from driveway entrance to main residence. Subject property spans both sides of the dirt road, and extends up a portion of the hillside in the right background.
